Stone Restoration and Preservation Philosophy:
A case study of brownstone restoration at 951
Boylston Street, Boston, MA.

Presented to Boston Architectural College
In Fulfillment of the Requirements for the degree of the
Master of Design Studies in Historic Preservation

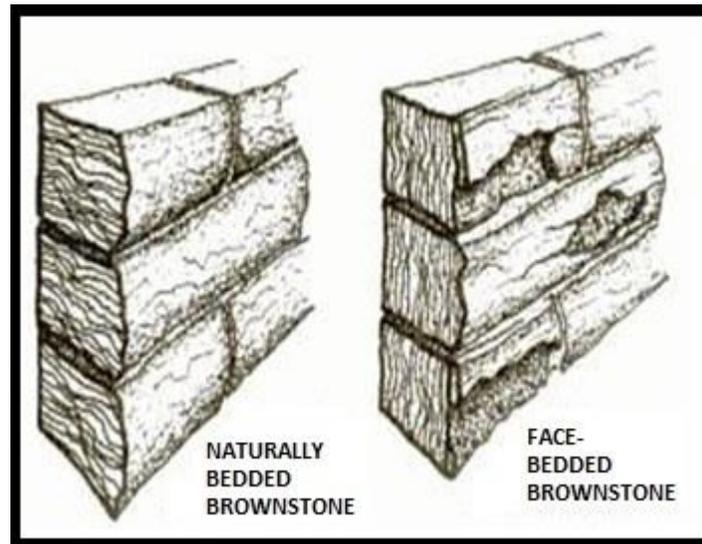
Naturally bedded stones (left) suffer less damage from the weather than face-bedded stones (right)¹³

above the other. Consequently if the stone is not laid naturally bedded but face-bedded, this being the incorrect way, it will cause flaking of the stone over time due to water damage.¹²

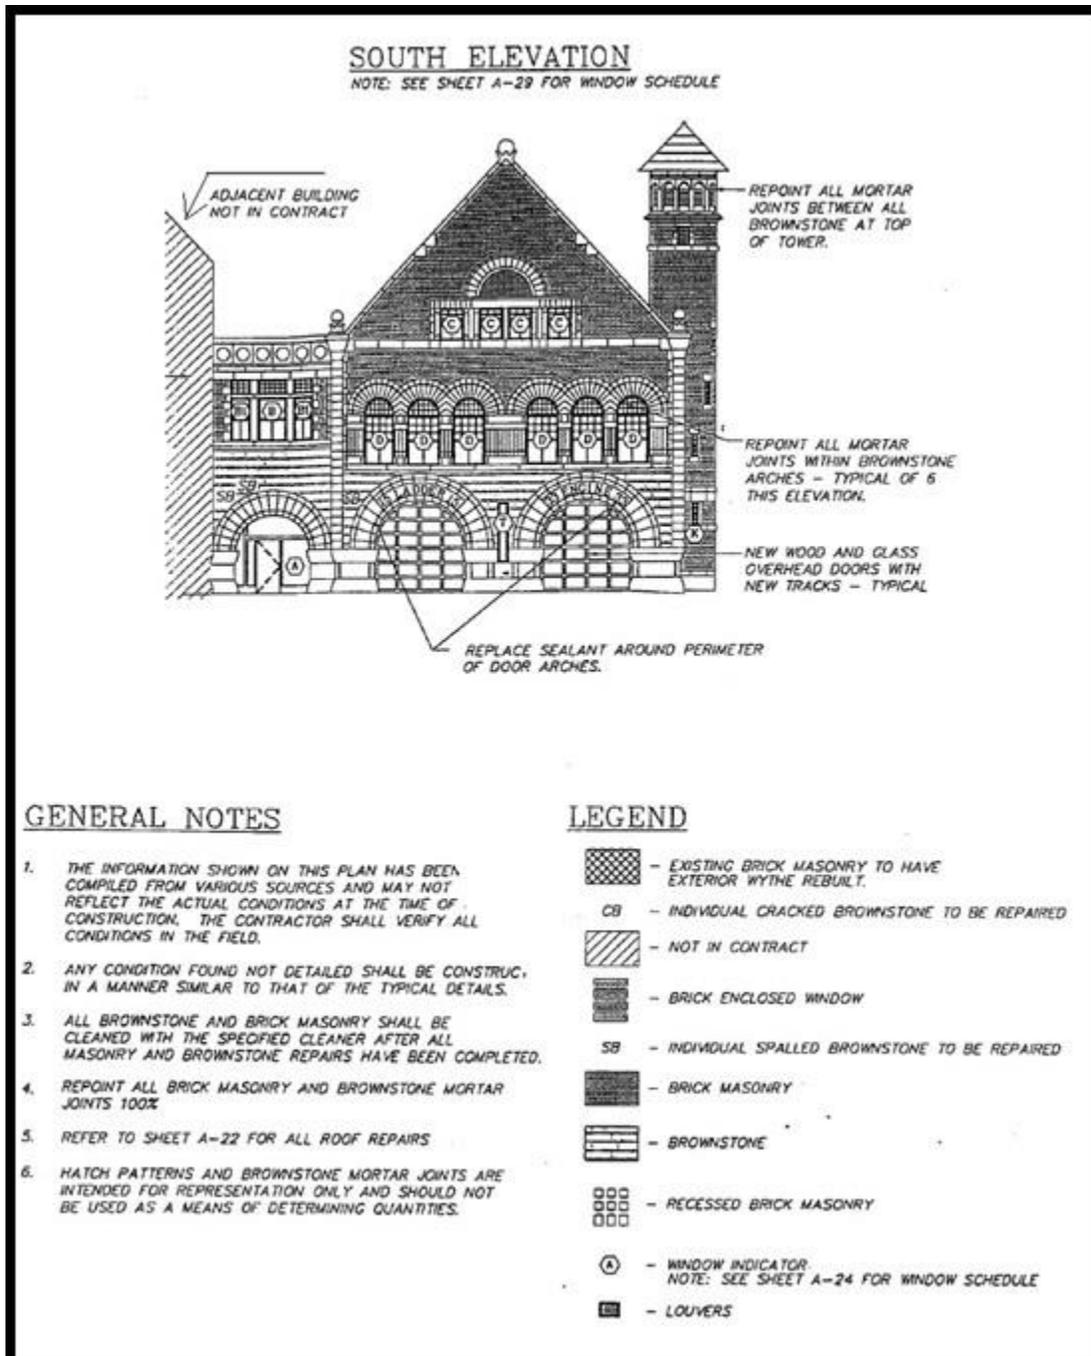
The south elevation key created by Gale Associates of Weymouth, Massachusetts for 941 Boylston Street restoration work.⁵⁴

In 1997 repair work on 941 Boylston Street was undertaken by Gale Associates of Weymouth, Massachusetts. They were to handle extended repair and repointing work along with windows. With respect to the brownstone repairs, the goal was to clean all brownstone and brick masonry with a specified cleaner, once all repairs to each stone had been completed. Spalling did appear on individual brownstone so brownstone repair work included these repairs as well. Repointing of all brick and brownstone mortar joints including the arches above windows and the mortar joints at the top of the tower were also completed.⁵³

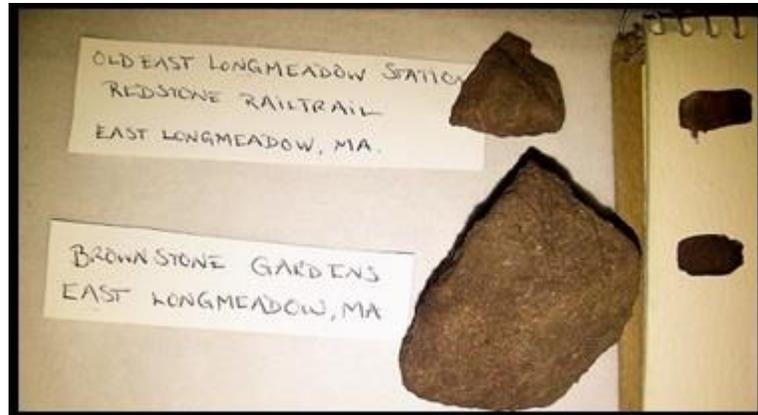
Color analysis for brownstone from East Longmeadow, MA ⁷⁷

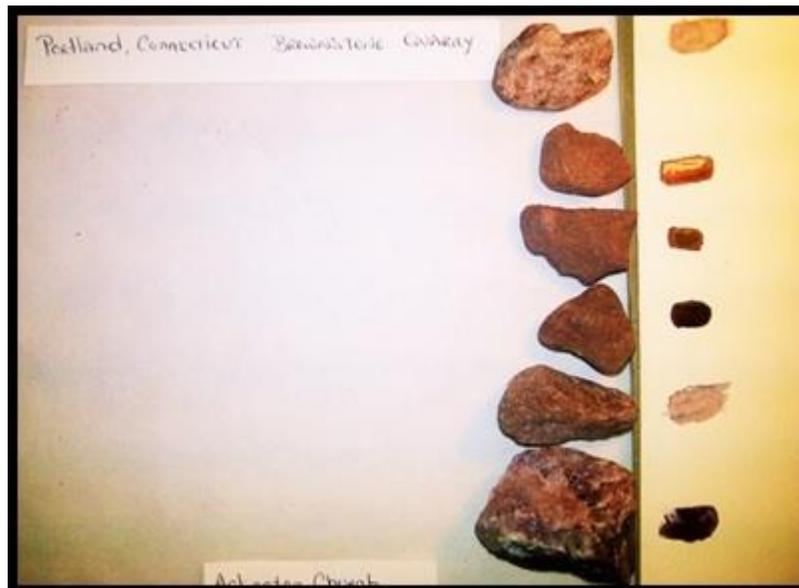
Color analysis for brownstone from Portland, Connecticut ⁷⁸

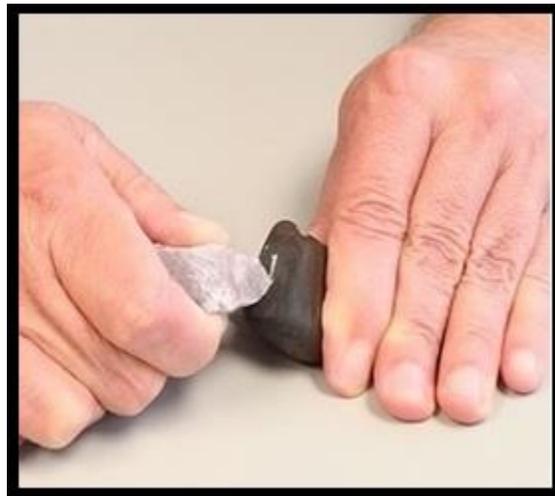
Mohs Hardness scratch test ⁸²

The Mohs Hardness Test uses the 10 minerals to prove whether a stone is harder or softer than that mineral. To test the “hardness” of brownstone, for example, you would take one of these minerals and test it by scratching the surface of the brownstone. If the first mineral, Talc is scratched against the surface of the brownstone and the Talc doesn’t leave a scratch then the brownstone is harder than talc on the Mohs hardness scale. You would then continue to work your way through the minerals until you either found a mineral of equal hardness, where they would not be able to scratch each other. Or if for example the brownstone is able to scratch the Fluorite (4), but the Apatite (5) is able to scratch the brownstone, it would then have a hardness of 4.5 because it falls between the two minerals on the Mohs Hardness Scale.

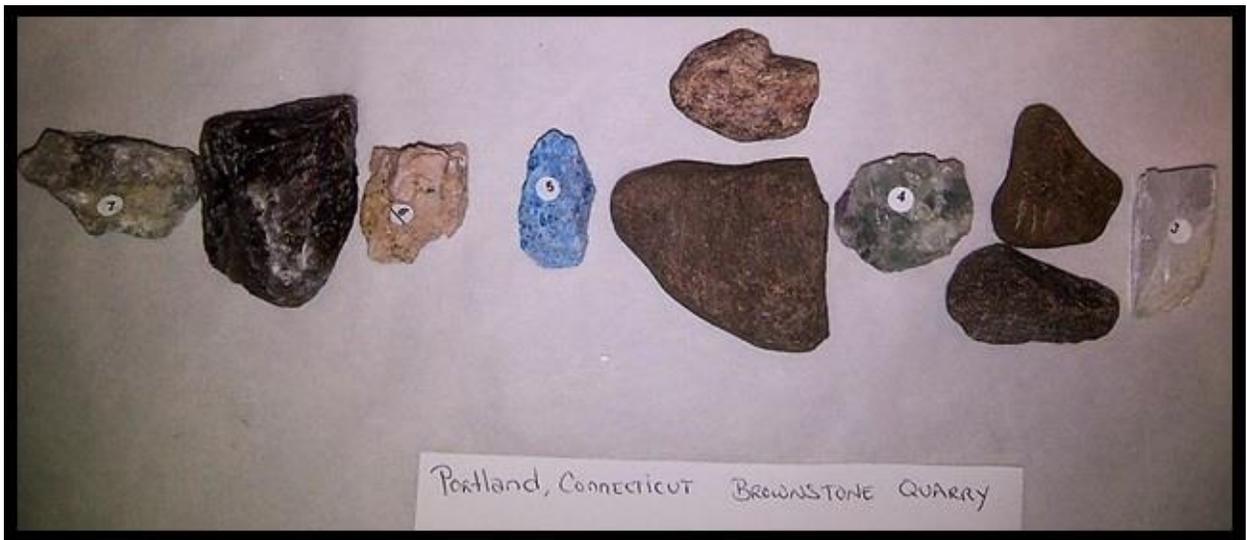
Multiple pieces and colors of brownstone were found at the Portland, Connecticut quarry, now the Brownstone Exploration and Discovery Park. Here brownstone is laid out from left to right in the order of the “hardest” stone to the “softest” stone.

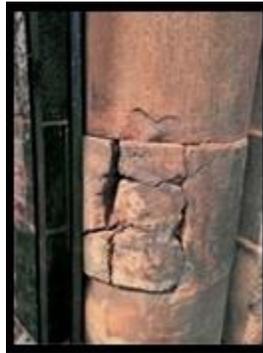
*Impact Damage*⁹²

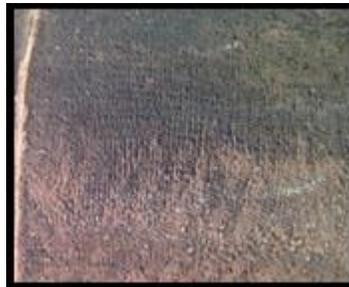
*Scratch*⁹³

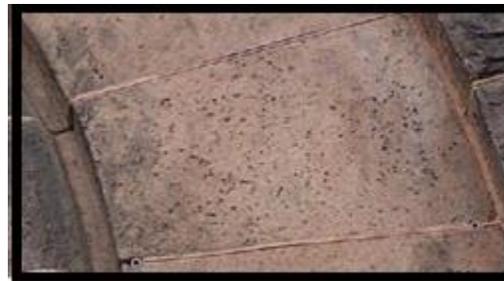
Pitting⁹⁴

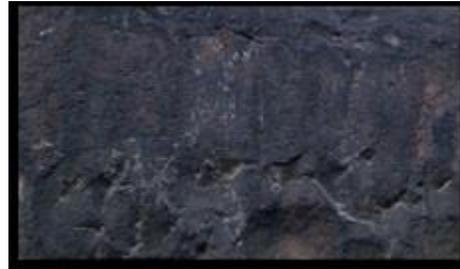
- a) *BLACK CRUST*: Kind of crust developing generally on areas protected against direct rainfall or water runoff in urban environment. Black crusts usually adhere firmly to the substrate. They are composed mainly of particles from the atmosphere, trapped into a gypsum ($\text{CaSO}_4 \cdot 2\text{H}_2\text{O}$) matrix.
Example:

*Black Crust*⁹⁵

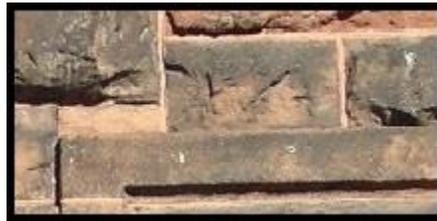
- b) *SALT CRUST*: Crust composed of soluble salts, which develop in the presence of high salt levels, and form from wetting and drying cycles.
2. *DEPOSIT*: Accumulation of exogenic material of variable thickness. Some examples of deposits: splashes of paint or mortar, sea salt aerosols, atmospheric particles such as soot or dust, remains of conservation materials such as cellulose poultices, blast materials etc...
Example:

*Deposits*⁹⁶

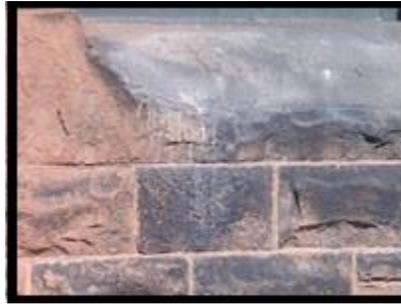
*Staining*⁹⁷

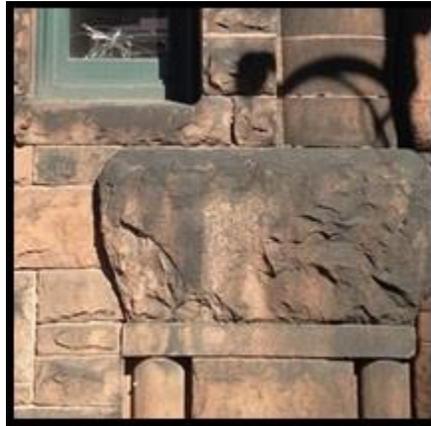
occur.”¹⁰⁵ The mortar on portions of 951 Boylston has most likely been repointed in the past. Deterioration can be seen in various areas where mortar would need to be restored. If the existing mortar had been created to be too “hard” then it would need to be repointed and recreated to be a similar color and at a level of “softness” to be consistent with the original mortar which had appeared on the facade.

Mortar missing between the brownstone column pieces

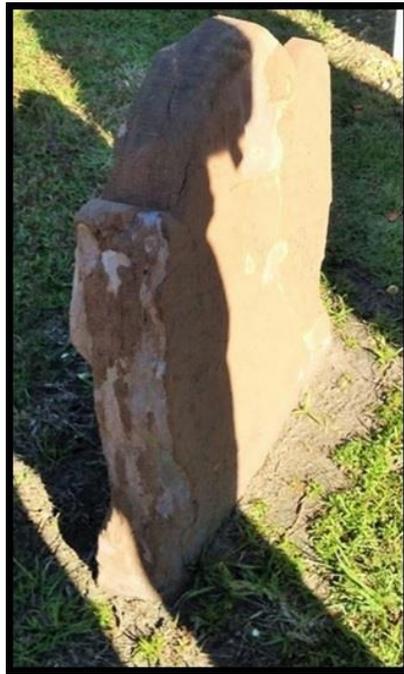
Tablet style tombstones made of brownstone are an example of stone that tends to have case hardening issues. Since it is created of one piece of brownstone and is partially buried underground, it acts like a sponge, absorbing moisture from the ground up into the stone. If the portion that is above ground has been sealed it will still wick up moisture and salts and won't be able to dry out. This is when case hardening occurs. A harder protective crust will form on the outside of the stone which will weaken the interior of the stone and portions of the stone over time will fall away.¹¹²

Savannah, Georgia, brownstone tombstone where an example of case hardening can be seen¹¹³

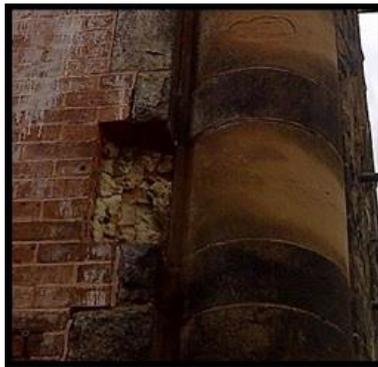
Occasionally a portion of a brownstone façade needs to be replaced. If this is the case “unit replacement” is an appropriate approach. Natural stone or cast stone can be used as a replacement unit. Unfortunately brownstone material is harder to obtain with so many quarries closed, another option for replacement is salvaged material from buildings which have been demolished. Another option would be to obtain a similar stone which closely resembles brownstone. When the stone is attached to the façade, always make sure it’s laid as it was naturally bedded so as not have immediate weathering issues. Cast stone is a third option where precast concrete is tinted and refinished to resemble the original brownstone. This is an economical and more durable option especially for such areas as stair treads. The use of crushed brownstone can be used in the cement mixture along with sand and coarse aggregate, this will create a durable color match to the original brownstone. The natural stone replacement would be the appropriate choice for a unit replacement repair.¹¹⁷

*A missing piece of brownstone from 951 Boylston Street, Boston*¹¹⁸

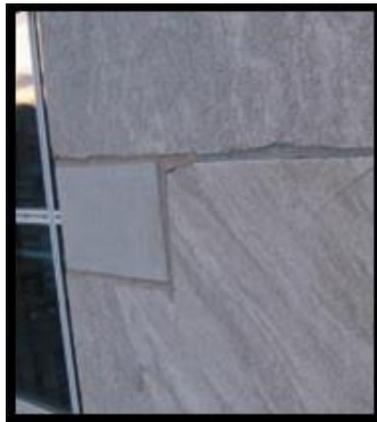
When a composite repair is not feasible, or unlikely to last, a “dutchman” repair is used. A stone dutchman is when a piece of stone is cut and set into a larger piece of stone which has been damaged or is missing a piece of its original stone. A dutchman is beneficial to use in areas that are exposed to wet conditions because it will generally be more durable and more visually appealing than a composite repair. A “full face” dutchman may be used for deterioration which has occurred to a significant depth and the stone surface needs to be durable. Oftentimes a dutchman is used where an exposed repair overhangs an entry or sidewalk and the failure of a composite repair could create a hazard.¹¹⁹

*Dutchman Repair*¹²⁰

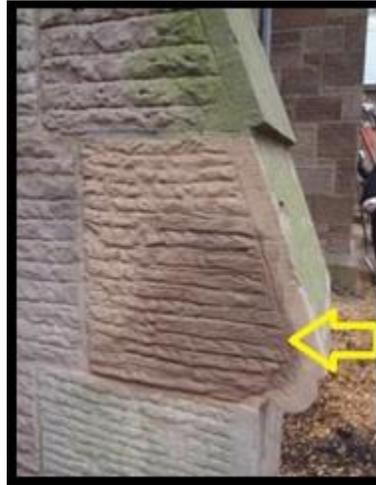
repair is more difficult. Retooling a surface is only advisable if the outcome will be similar to the original surface.¹²¹

*An example of a retooled brownstone surface*¹²²

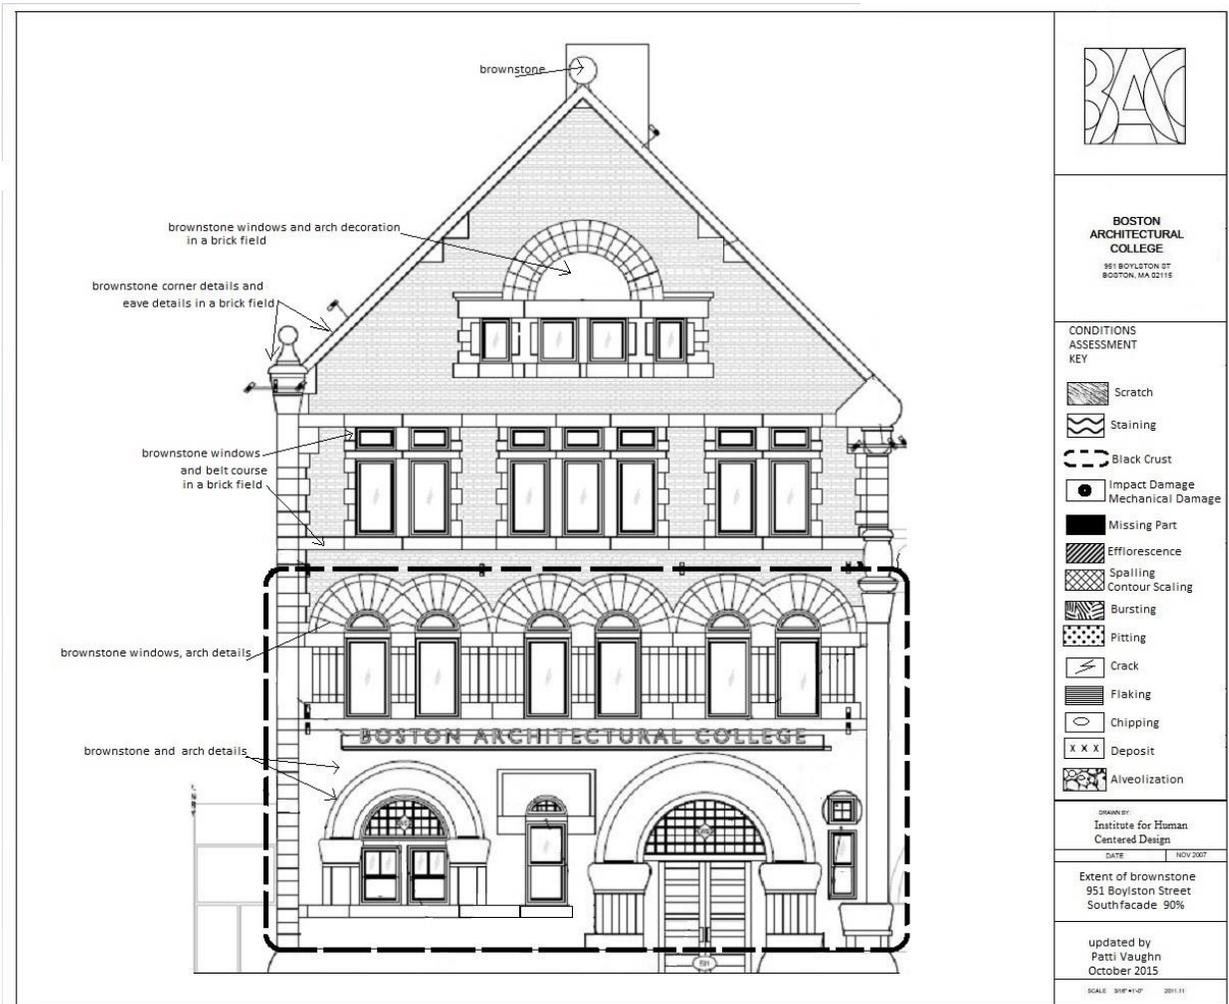
951 Boylston Street, south façade, extent of brownstone

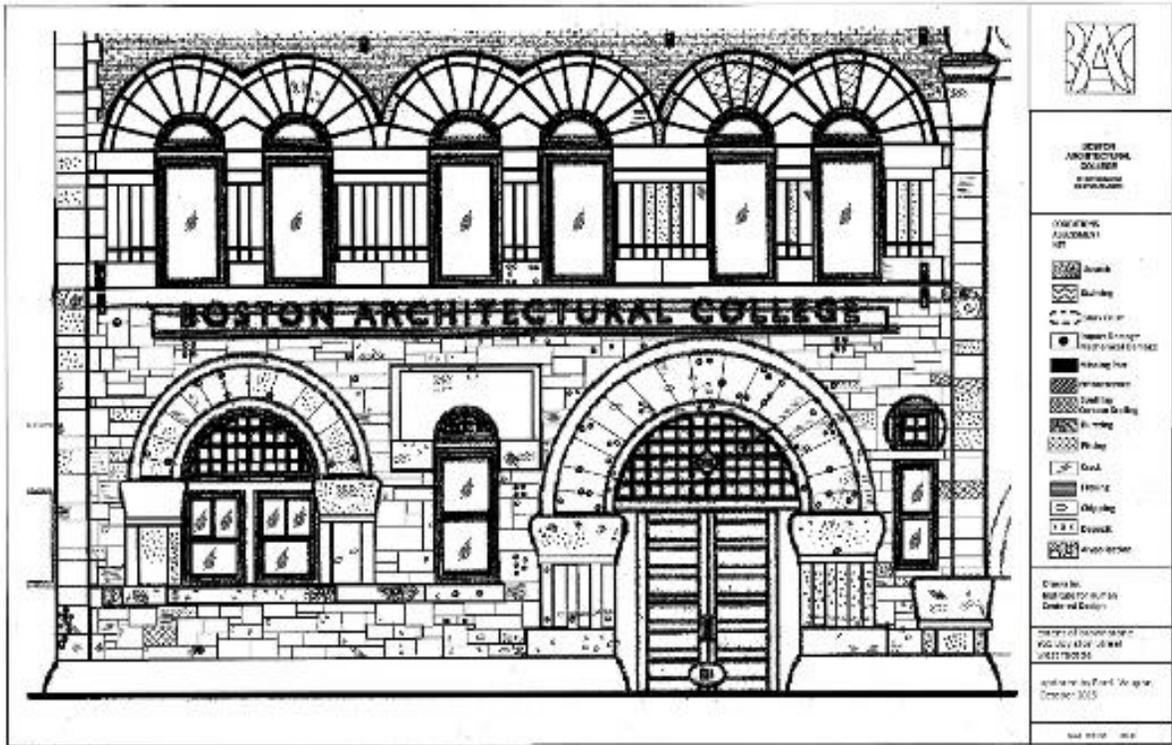
951 Boylston Street, south façade, conditions assessment

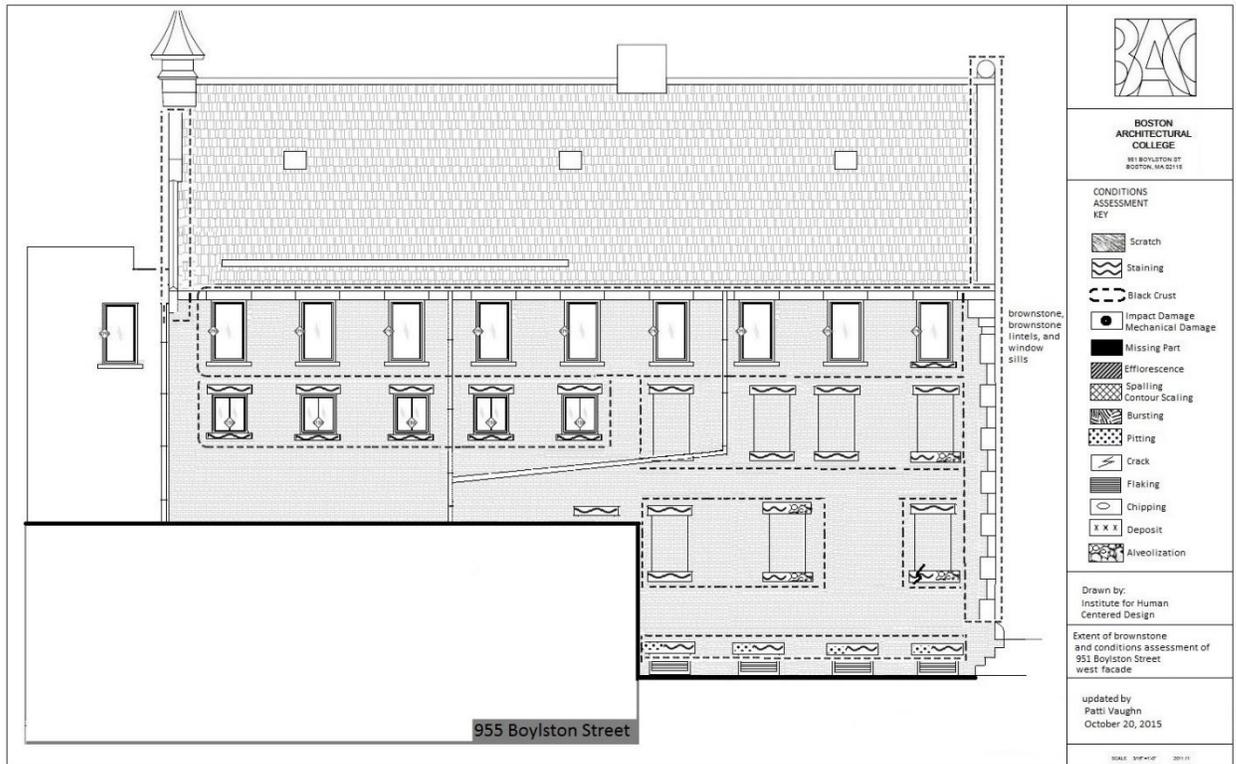
951 Boylston Street, west façade, extent of brownstone and conditions assessment

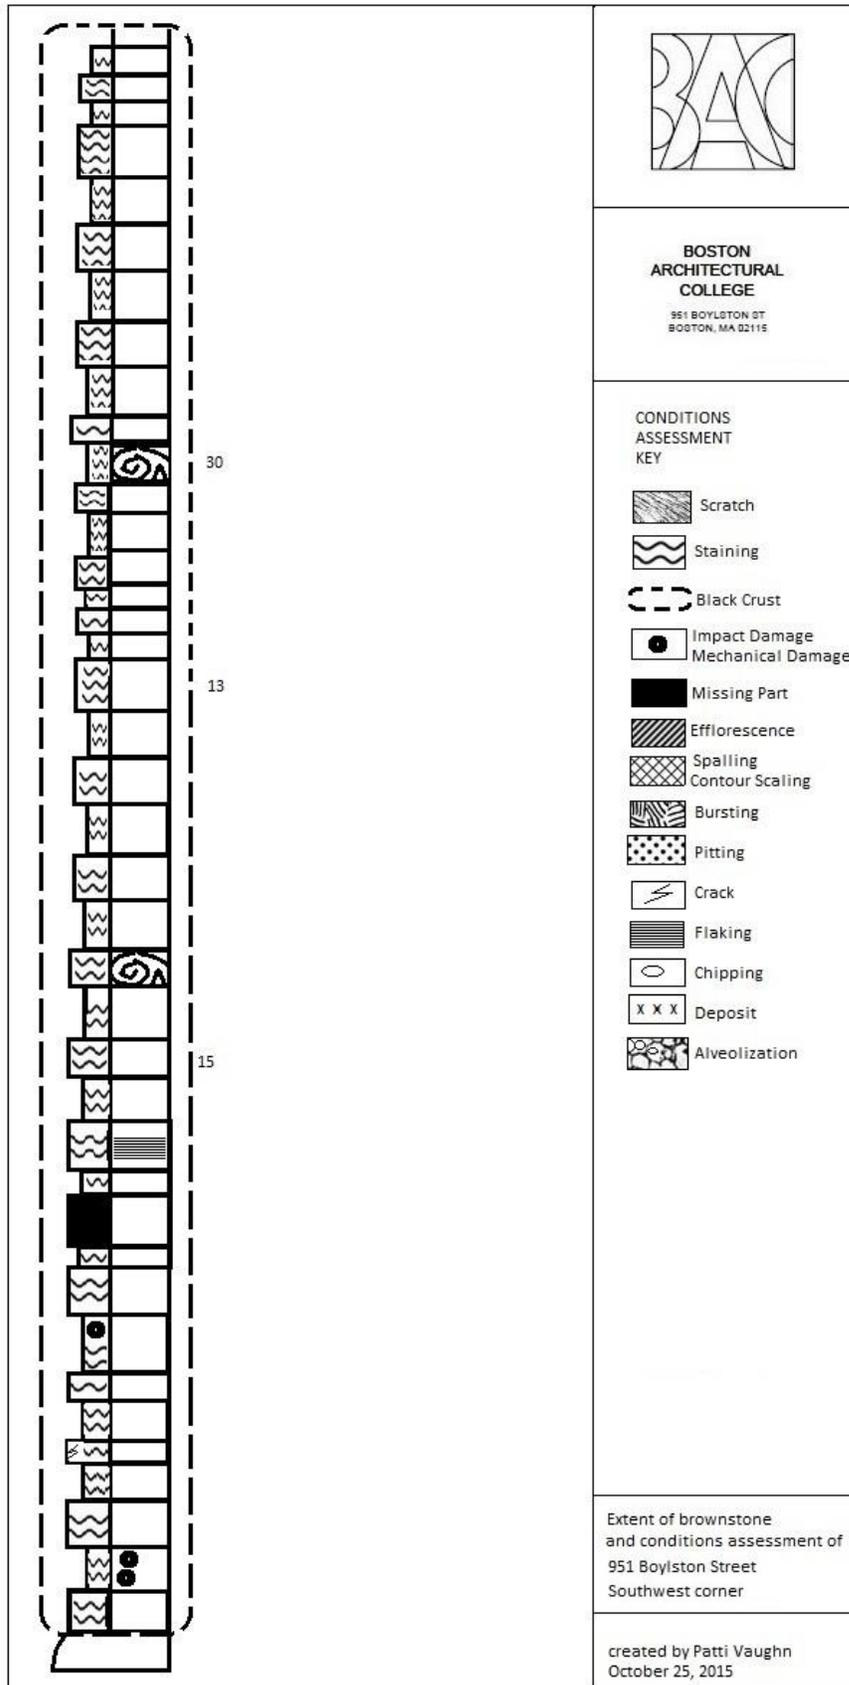
951 Boylston Street, southwest corner, extent of brownstone and conditions assessment

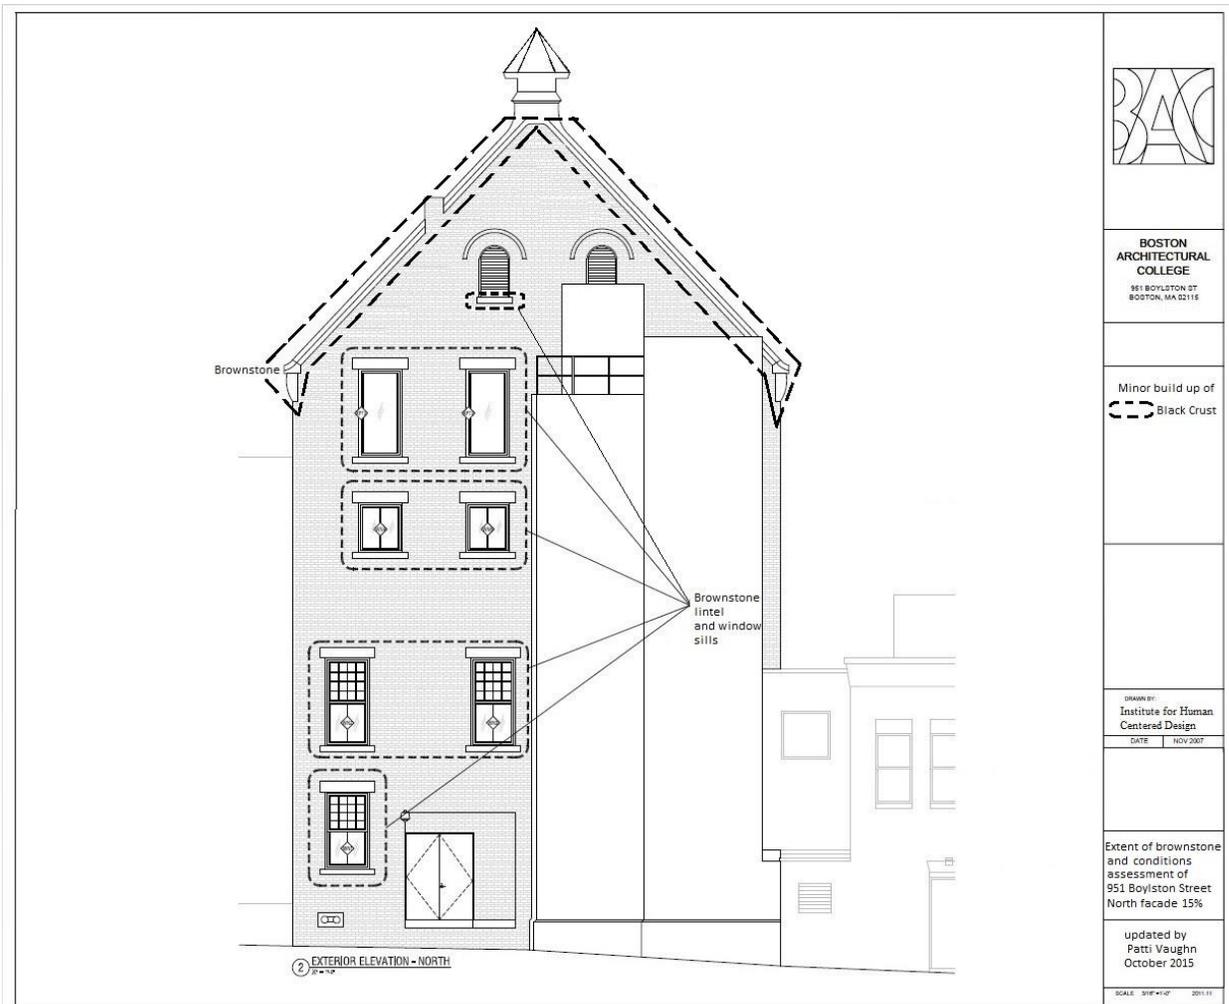
951 Boylston Street, north façade, extent of brownstone and conditions assessment.

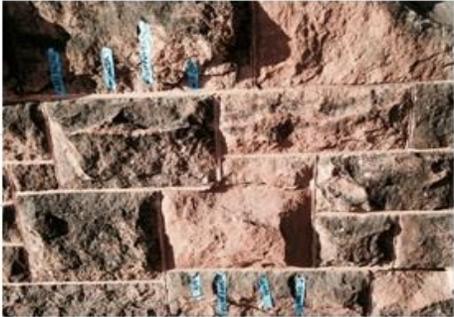
<p>2. STONE DURING CLEANING 951 Boylston Street, Boston, MA 2 brownstones tested November 2, 2015, 3:15pm, 63 degrees F stones are damp after marked portions of each stone have been cleaned with a Soft dry brush, lukewarm water, 1 Tablespoon of non-ionic liquid ivory soap & 1 cup of lukewarm water and D/2 Biological Solution-soaked for 10 minutes</p> <p>Cleaning to stone with black crust Soft dry brush, water, soap & water, D/2</p>

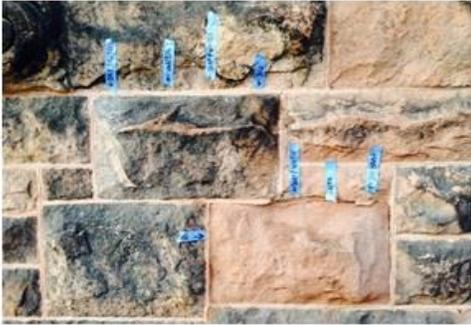
<p>3. STONE ONE DAY AFTER CLEANING 951 Boylston Street, Boston, MA 2 brownstones tested November 3, 2015, 3:00pm, 61 degrees F After being cleaned with: Soft dry brush, lukewarm water, non-ionic liquid soap & lukewarm water, D/2 Cleaning to stone with black crust</p>

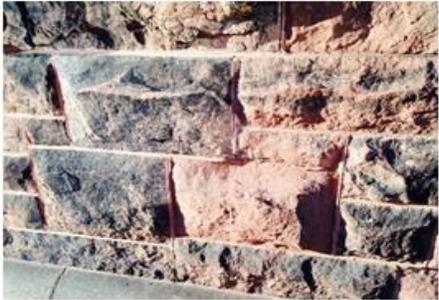
<p>D/2, soap & water, soft dry brush Cleaning to stone with spalling</p>

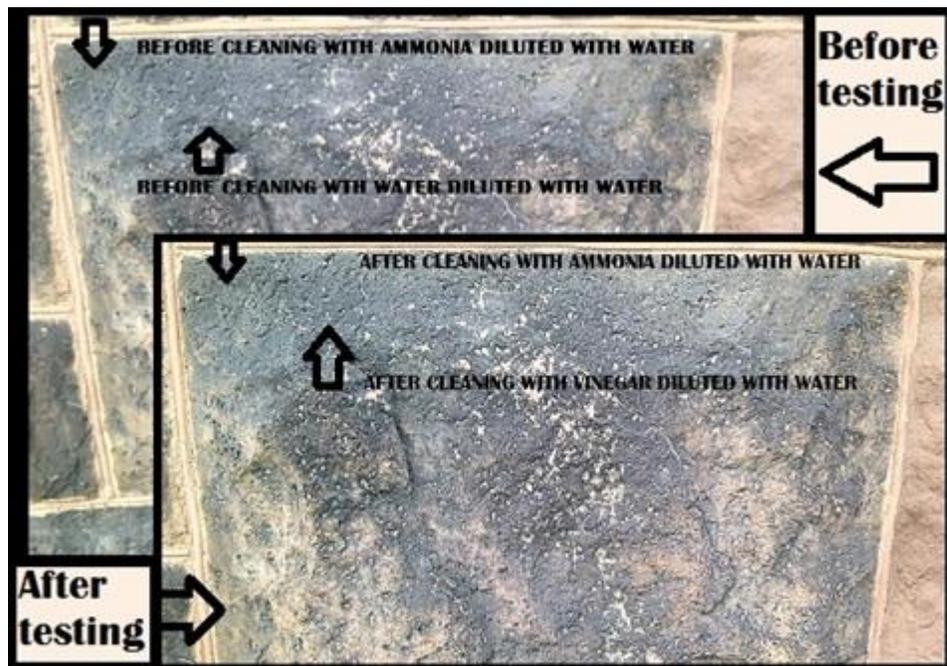
A spot test using ammonia diluted with water and a second spot test using vinegar diluted with water¹³⁵

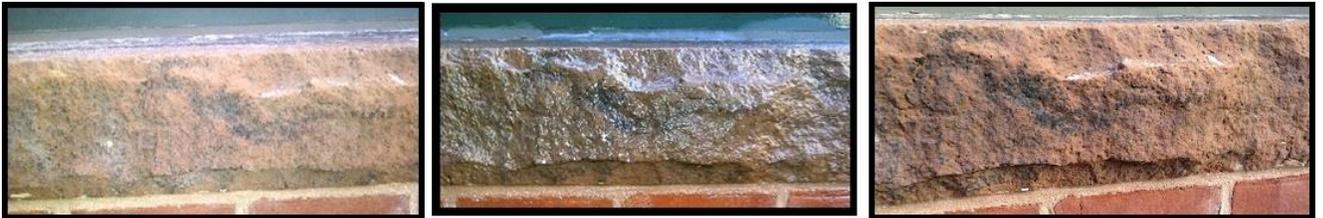
The brownstone window sill, before, during and after pressure washing [Left to Right] ¹³⁷

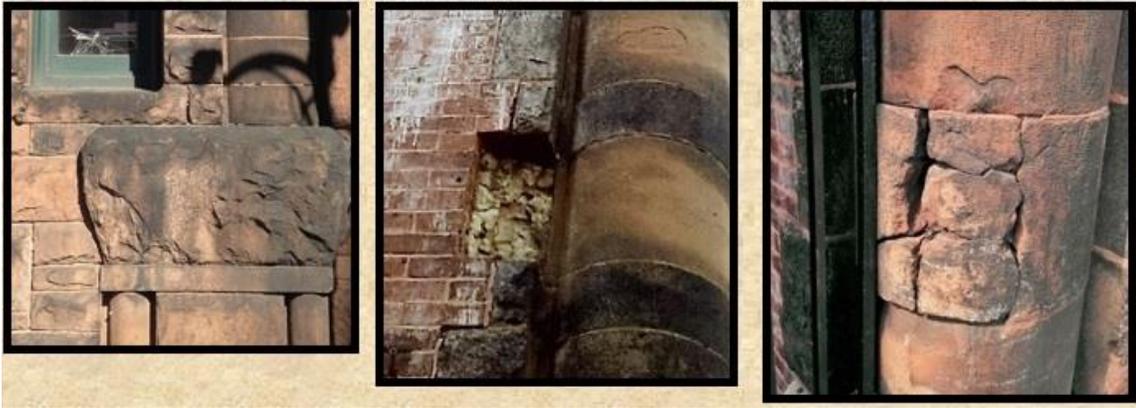
Repointing, missing piece of brownstone, and impact damage located on 951 Boylston Street, Boston, MA. [Photos Left to Right]
